**2024 Chesapeake
AIHA/ASSP Educational
Seminar**

**Mercury in Rubber Gym
Floors: Overview and
Lessons Learned**

March 2024

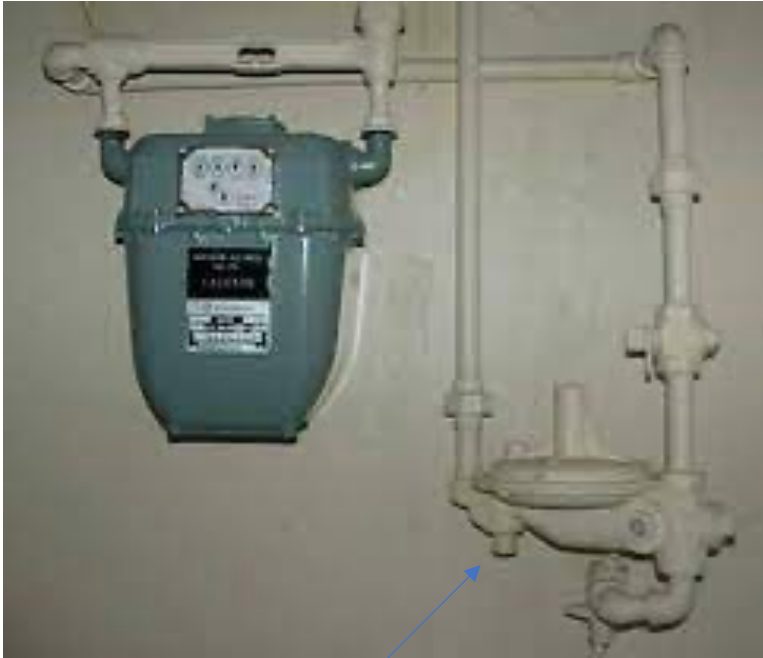
Mercury cup with ~2 tsps. of liquid mercury

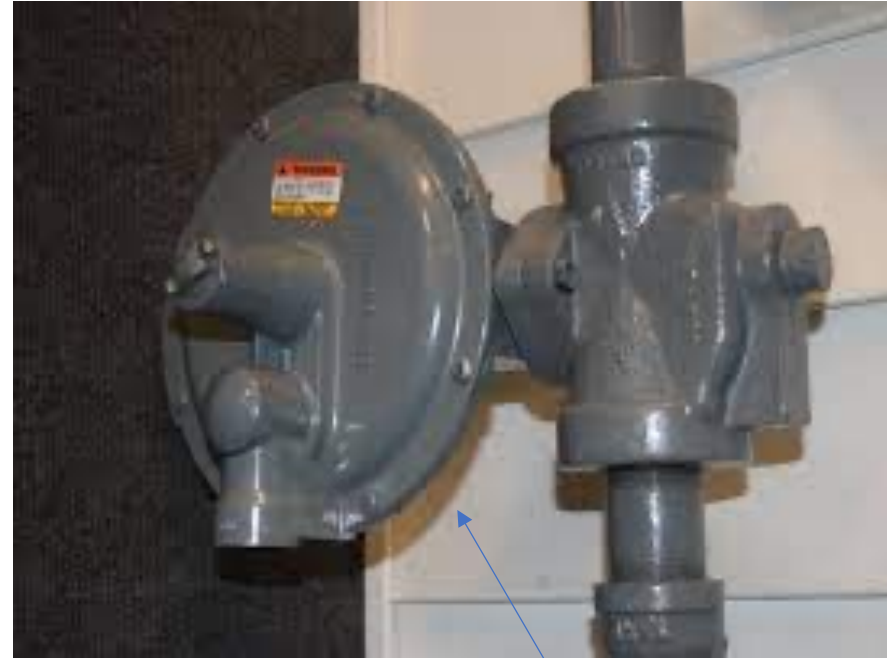
This orientation means no mercury

Liquid mercury vials move as switch is activated

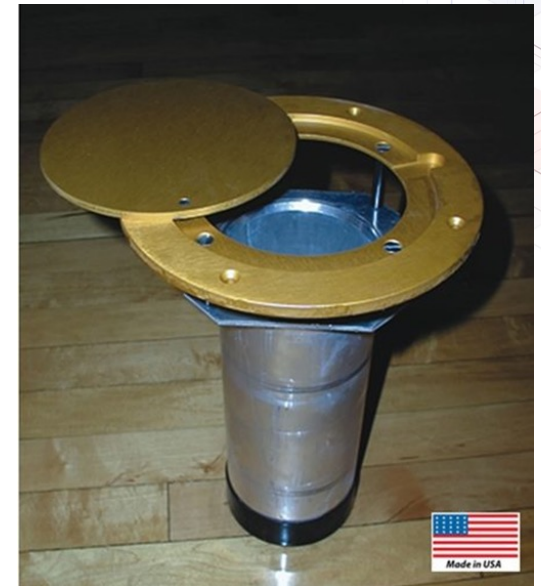
- Mercury finds the lowest point in which to hide
 - Cracks, receptacles, and holes may be more contaminated
- Issue: High initial concentrations were found in the volleyball post sockets
- Strategy: Sockets were removed for inspection
 - Debris, pits and general deterioration inside
- Sockets cleaned out in all three schools that had them
- Monitoring focused on these areas until clean and clear
